December 2014

Welcome to the December 2014 Height Safety News. This month we put the spotlight on false-work layouts and edge protection, introduce the holy grail of height safety, report on an edge protection failure, and wish you all a very Happy Christmas.

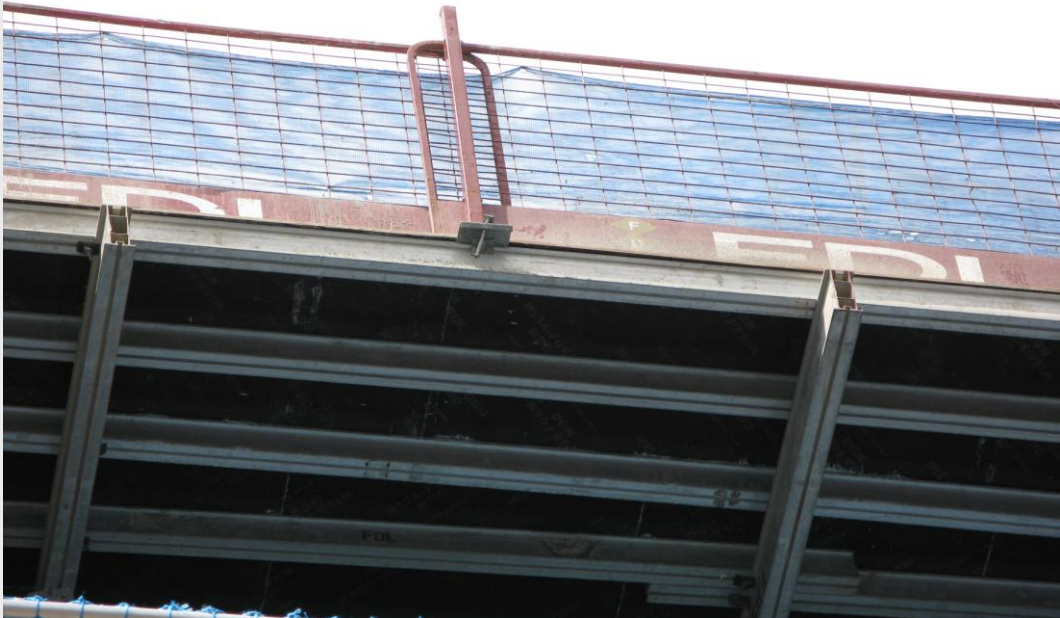
Hazardous Temporary Edge Protection

The most common mistake in the installation of temporary edge protection, is installing on the secondary false-work beam, when running in line with the protected edge. Nothing is holding this secondary beam to the structure, and a failure of the edge protection and the beam is an accident waiting to happen. I have at last realised the cause of this regular oversight on the part of the edge protection installers, and I recognise that I have been addressing the wrong group with training and inspection feedback.

The false-work designers are the cause, as they fail to include the "over-sail" of the primary beams on their layout drawings. The false-work erectors follow the

drawing, laying the beams out to the lengths indicated and not accommodating the additional space needed to support the edge protection post clamps... (they also waste significant quantities of ply by notching around the clamps).

The edge protection systems are all designed in a similar way, and if we can get this message across to those who draw the false-work layouts, we will solve the most common problem in the use of this equipment.

(.. please also note that technical confirmation should have been requested to add the debris overlay to the edge protection. This increases the wind load significantly).

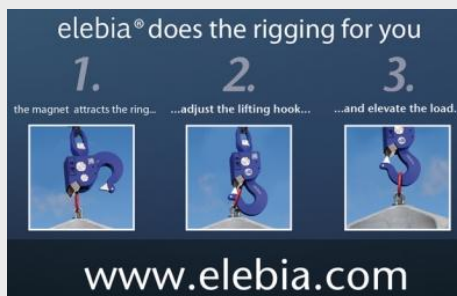
Remote Control Crane Hook

The opportunity to
avoid working at

height is the "holy grail" of height safety, and the Elebia remote control crane hook delivers just that. At last this simple, robust, effective, solution is making itself known within construction. It is available through a number of plant hire companies, and has been purchased for use on some of the largest and most carefully managed projects, like Crossrail. Check it out at [Red Plant](#)

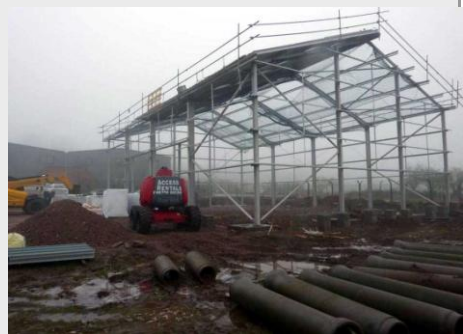
7m Fatal Fall

A significant fine has
been imposed after a
fatal fall on a roof
sheeting project in late

2010. Safety nets were in place on the project, however it was the standard of edge protection provided proved to be the cause. the roof pitch was 20 degrees which demands a higher Class of edge protection within EN 13374.
