November 2014

Welcome to the November 2014 Height Safety News.

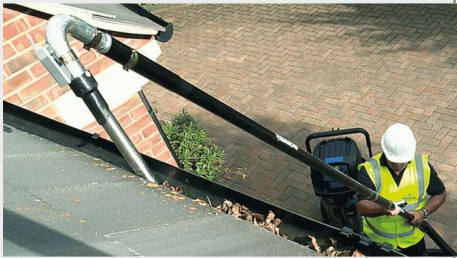
Avoid Work at Height.

The best practice principle of avoiding work at height, is well demonstrated by the [SpaceVav](#) gutter cleaning equipment. There is a wireless video camera mounted on the head, and a reach of 14m. It is not a unique product or concept, but it clearly demonstrates the opportunities and benefits of avoiding work at height.

These products both support the first principle of working at height **..avoid it if you can !**

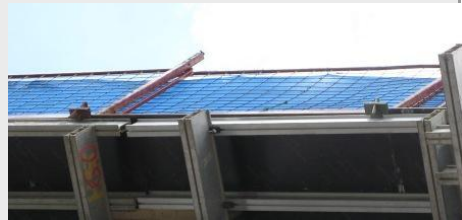
False-work layout is the key.

The most common error when fitting edge protection to a false-work system, is installation on the secondary beam when it is running parallel with the protected edge. This results in a significant potential failure, and occurs on almost every project I have visited over the years. The edge protection systems are designed to be installed to the primary

beams in this orientation, but this detail is frequently overlooked by the installers.

Part of the solution is training and awareness, however the most significant contributor to the creation of this problem, is the temporary works designer who draws the form-work layout. The primary beams are not over-sailed on the drawing, beyond the working deck, to accommodate the edge protection foot. Fix this detail, and the problem will go away.
